# Manhole Inspection Summary

Manhole # S25AA\_019MH

Insp Date: **9/13/07 8:52 AM**

**Location** Address: **814 CAREY ST**

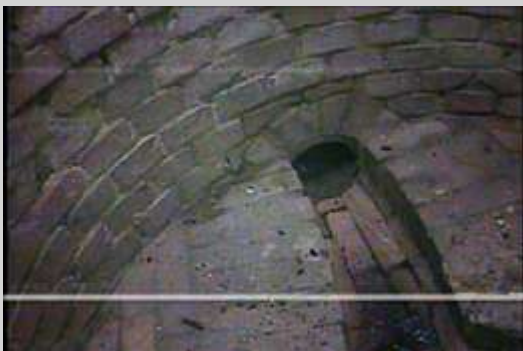
4 O'Clock Inflow

6 in. Circular Gravity Sewer  
Pipe In @ 4 O'Clock

Pipe Height: **6** (in.) Rod and Bar (Angled)  
Pipe Material: **Clay** ☐ Pipe Lined  
Invert Depth: **8.30** (ft.) Flow Characteristics: **None**  
Deposits: ☒ None ☐ Mud ☐ Sludge ☐ Debris ☐ Grease  
Silt Depth: (in.) Deposits Extent:  
Infiltration: **None** Pipe Seal Cond: **Sound**

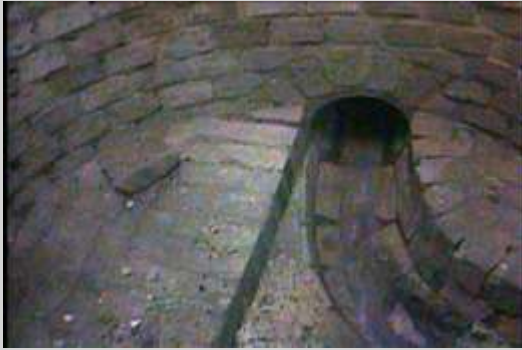
9 O'Clock Inflow

8 in. Circular Gravity Sewer

Pipe In @ 9 O'Clock

Pipe Height: **8.4** (in.) Rod and Bar (Angled)

Pipe Material: **Clay** ☐ Pipe Lined

Infiltration: **None** Pipe Seal Cond: **Sound**
